DEPARTMENT OF TRANSPORTATION

Quality Assurance and Source Inspection

Contract #: 04-0120F4Cty: SF/ALA Rte: 80 PM: 13.2/13.9File #: 1.28**WELDING INSPECTION REPORT****Resident Engineer:** Casey, William**Address:** 333 Burma Road**City:** Oakland, CA 94607**Report No:** WIR-026463**Date Inspected:** 04-Oct-2011**Project Name:** SAS Superstructure**OSM Arrival Time:** 700**Prime Contractor:** American Bridge/Fluor Enterprises, a JV**OSM Departure Time:** 1730**Contractor:** American Bridge/Fluor Enterprises, a JV**Location:** Job Site

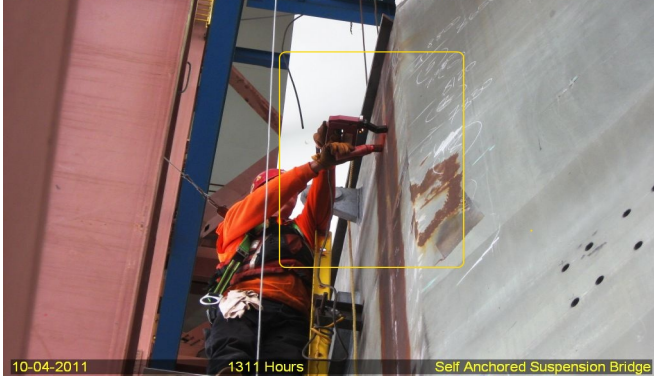
At Tower Base Electro Slag Welding (ESW) 80-100 transition butt joint location 'P' (face A), this QA observed ABF QC John Pagliero performed VT/MT on welded ESW. During the QC inspection, QC has found the completely welded ESW in compliance to the contract requirements except that four of the bolt holes close to the weld were plug welded. QA has brought this to the attention of QC Supervisor Bonifacio Daquinag who also informed this QA that this has also been brought to the attention of ABF QC Bill Norris and ABF Jim Bowers and awaiting response from them. This QA performed VT/MT verification and obtained same positive result except on the plug welded bolt holes.

At Tower Base Electro Slag Welding (ESW) 80-100 transition butt joint #N-043 location 'P', ABF QC-John Pagliaro was observed performing Magnetic Particle Testing (MT) on welded ESW.

During the QC inspection, QC has found the completely welded ESW in compliance to the contract requirements except that four of the bolt holes close to the weld were plug welded. QA has brought this to the attention of QC Supervisor Bonifacio Daquinag who also informed this QA that this has also been brought to the attention of ABF QC Bill Norris and ABF Jim Bowers and awaiting response from them.

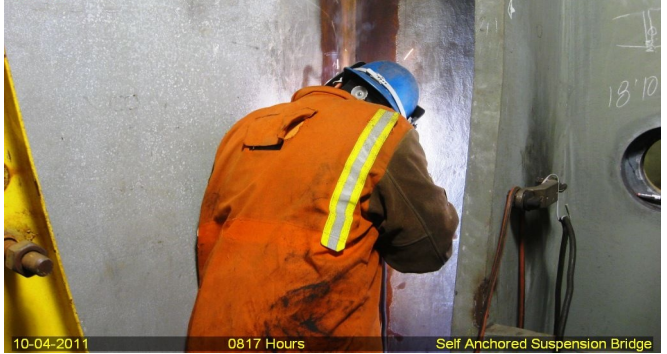
At Tower Base Elevation Electro Slag Welding (ESW) T-joint #W-045 location 'H' (face B), QA randomly ABF welder Richard Garcia continuing to perform 3G Shielded Metal Arc Welding (SMAW) cover welding repair due to excessive grinding on the visually noted overlap. The welder was observed welding in the 3G (vertical) position utilizing Shielded Metal Arc Welding (SMAW) with 1/8" diameter E7018H4R electrode implementing welding procedure ABF-WPS-D15-1000-Repair Rev. 2. The excavation was previously tested using Magnetic Particle Testing (MT) by ABF QC Salvador Merino and randomly verified by this QA with positive result. The repair excavation and the adjacent base metal were preheated to more than 300°F using the propylene gas torch. During the shift, ABF QC Salvador Merino was noted monitoring the welder. Measured welding parameter during welding was 140 amperes on a 1/8" diameter E7018H4R electrode. During the shift, weld cover repair at ESW location 'H' elevation 9 to 13 meters was completed and the welder has moved to elevation 0 to 9 meters of the same ESW location.

At Tower Base Electro Slag Welding (ESW) T-joint #W-045 location 'H' (face B), ABF welder Richard Garcia was observed performing 3G Shielded Metal Arc Welding (SMAW) welding cover repair on welded ESW.
